NOTICE OF ENVIRONMENTAL CONTAMINATION

VAPOR MITIGATION SYSTEM MONITORING, MAINTENANCE, AND REPAIR PLAN

The vapor intrusion mitigation system in the South Duplex is a passive system consisting of two lines of perforated vent piping (sub-membrane depressurization lines) installed beneath a vapor barrier in the building's crawlspace. A diagram of the system layout is shown at the end of this plan.

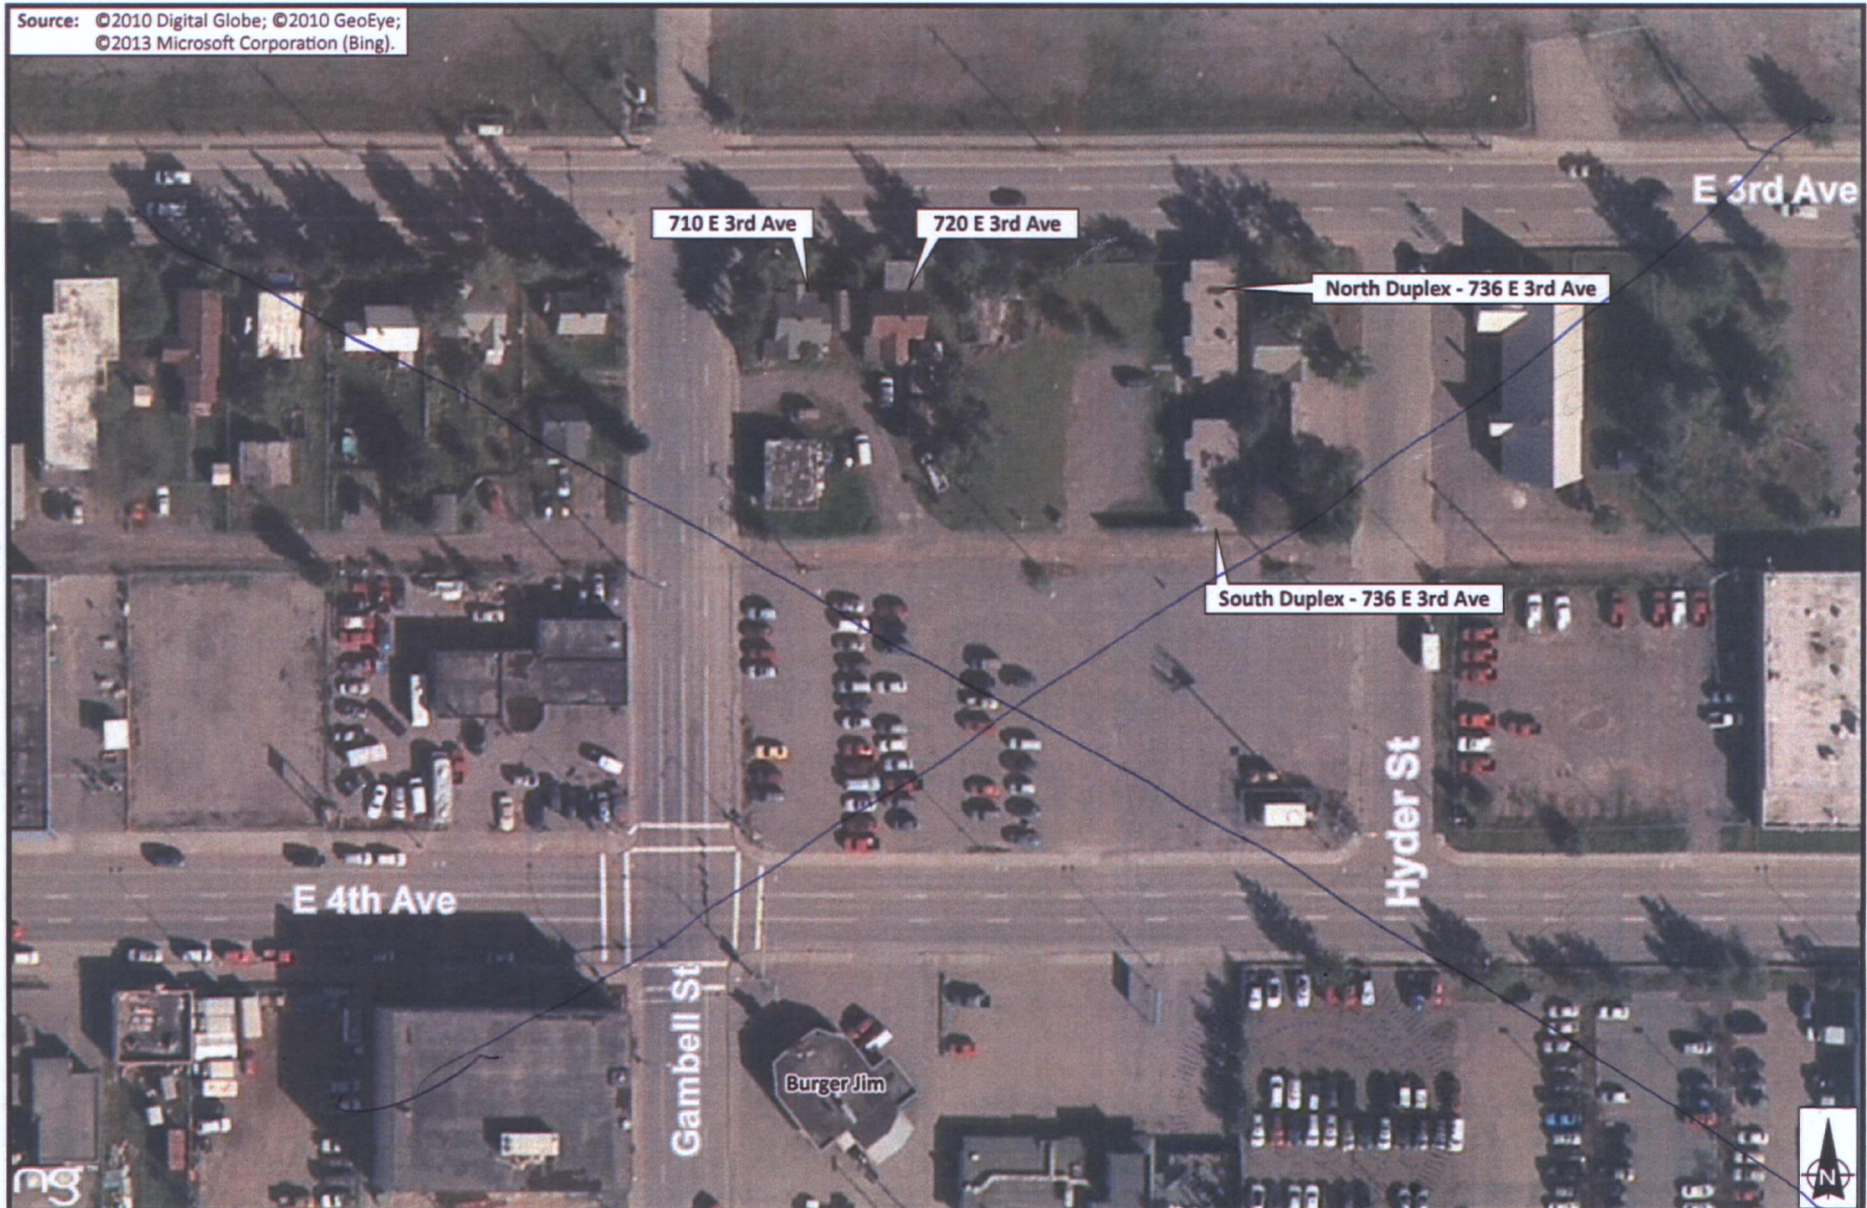
Figure 2
SITE MAP

FOURTH AVENUE AND GAMBELL PARKING LOT
Anchorage, Alaska

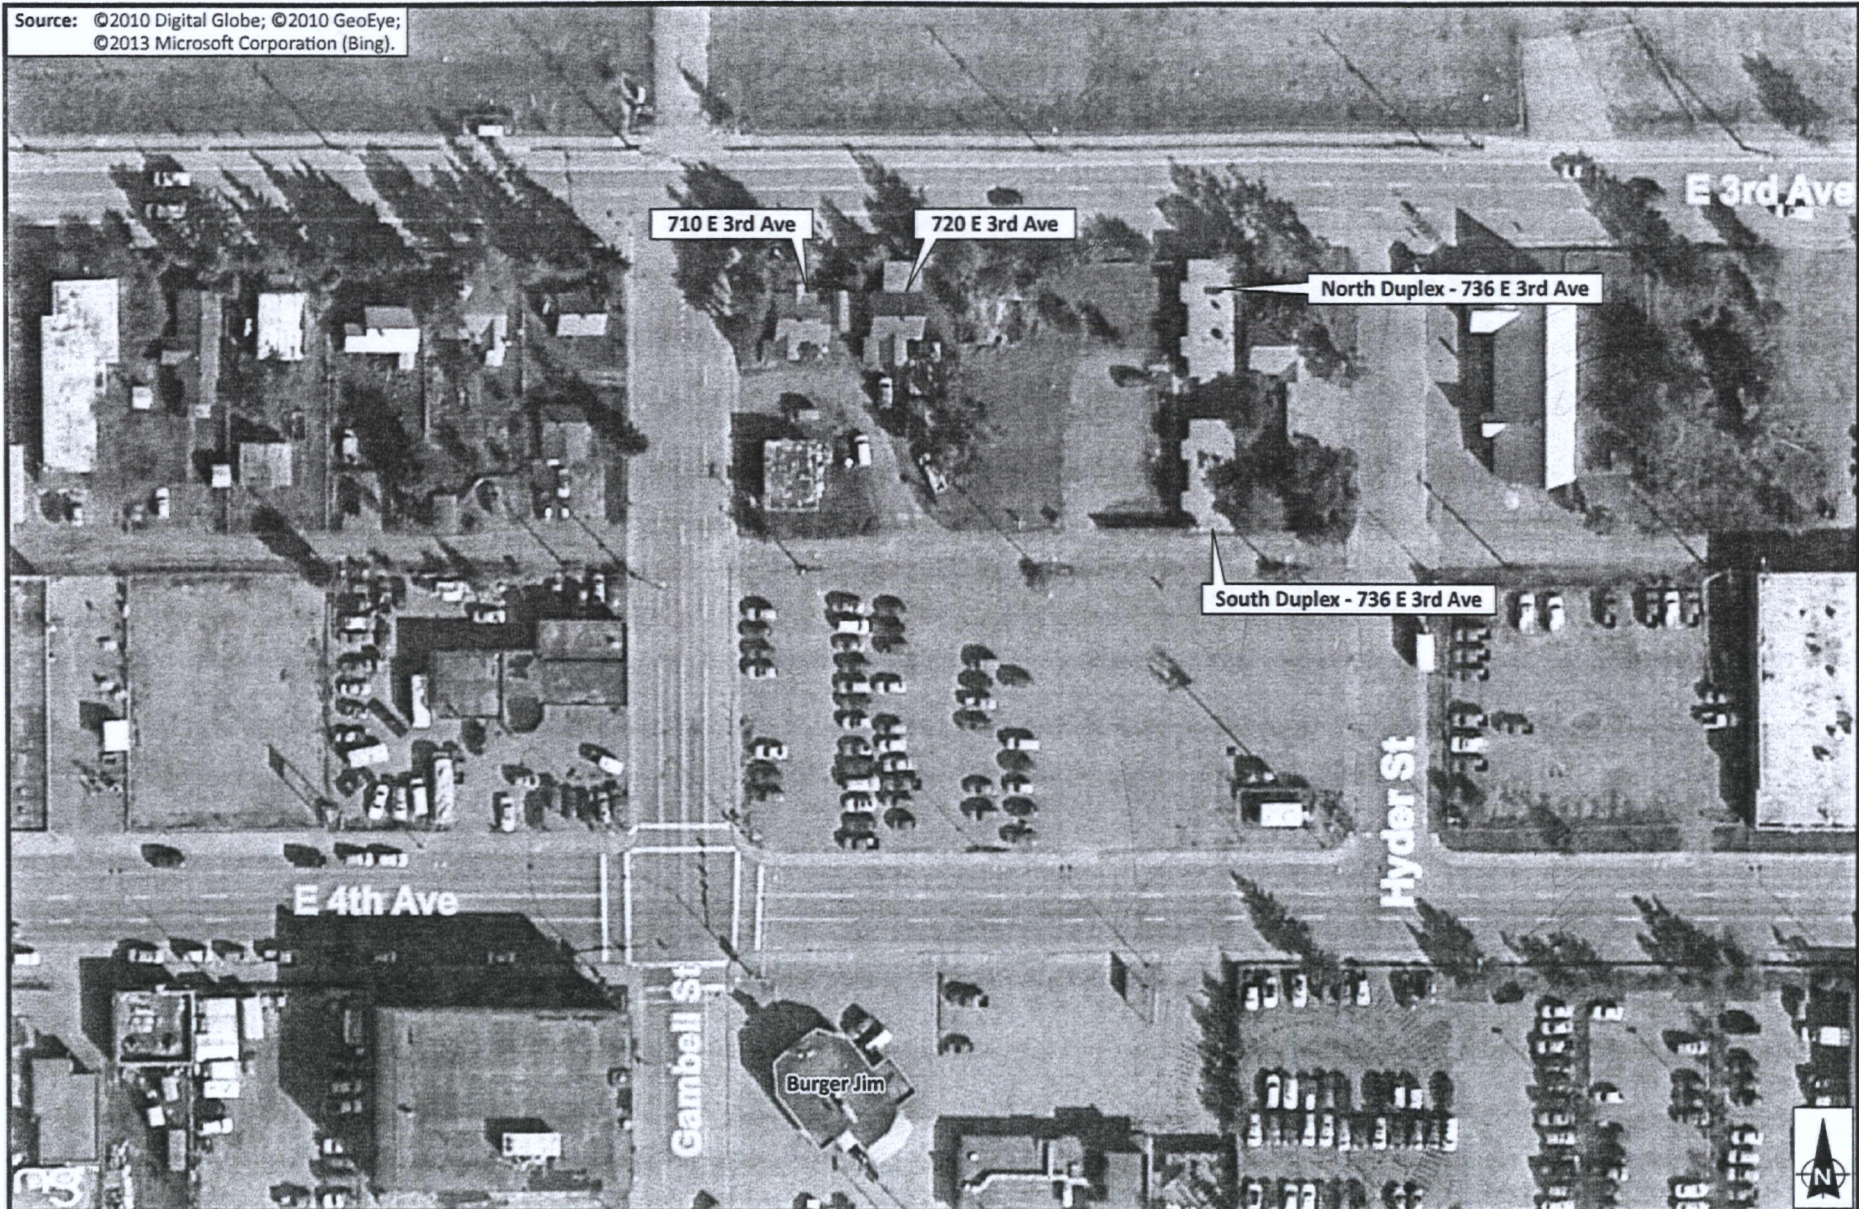
Figure 2
SITE MAP

FOURTH AVENUE AND GAMBELL PARKING LOT
Anchorage, Alaska

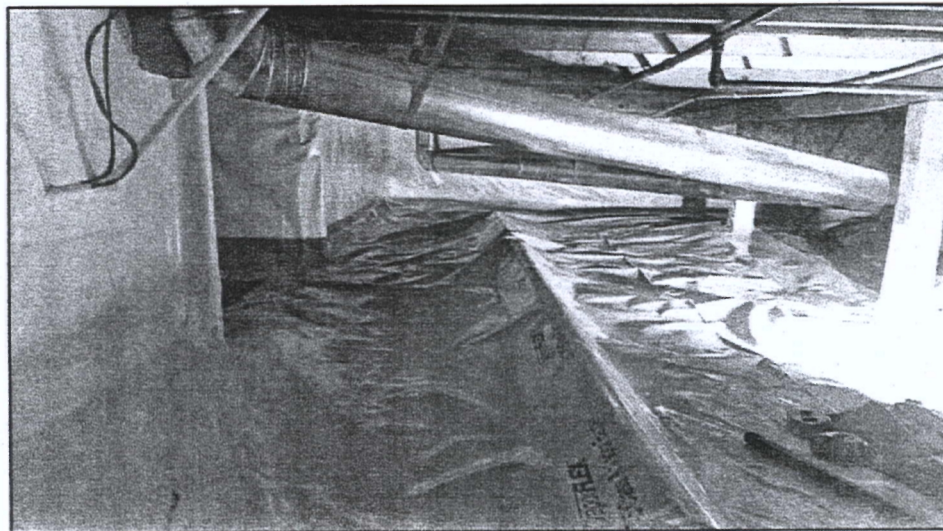
The vapor barrier is secured to the concrete walls of the crawlspace using a vapor barrier tape and plastic anchor plugs to seal the structure off from the contaminant vapors in the soil. The sub-membrane depressurization lines are constructed of 4-inch diameter perforated PVC piping. The perforated piping was installed beneath the vapor barrier to vent off volatile contaminants that build up beneath the barrier as shown in Photograph 1.

Photograph 1: Plastic vapor barrier encapsulating perforated ventilation piping.

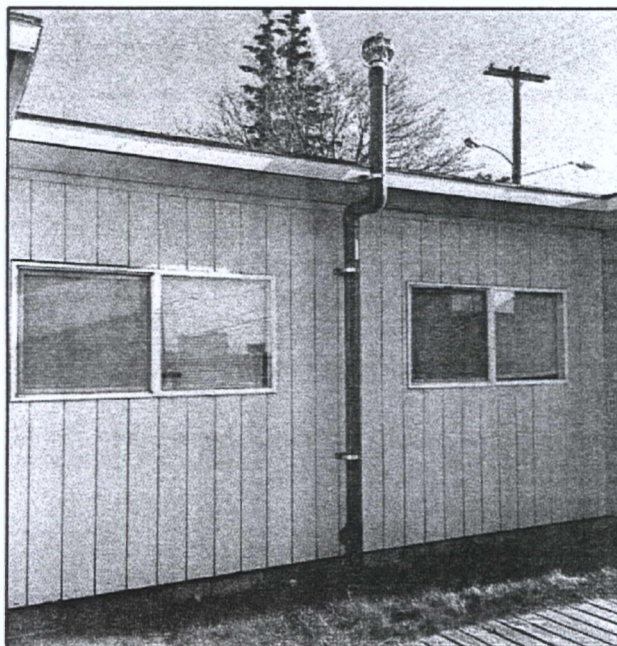
The two lines of perforated piping are located on the west and east sides of the building, extending north to south through the crawlspace. The perforated lines are connected to 4-inch diameter PVC conveyance piping that extends to exterior exhaust stacks on the west and east sides of the structure. Passive wind-driven ventilation fans were installed on top of the exhaust stacks to draw the contaminant vapors out of the building as shown in Photograph 2.

Photograph 2: Exhaust stack piping on the west side of the South Duplex building.

- Open the drain valves at the base of the exhaust stack twice a year in the spring and fall during non-freezing conditions to remove any condensation or precipitation from the exhaust piping.
